NORTHSTAR UNIT 7 SITE REPORT

May 2008

This report describes monitoring and results from the Northstar Unit 7 site (Unit 7) at Northstar-at-Tahoe Resort (Northstar), a year-round resort. The Northstar Resort is located in Placer County, California, just off Highway 267 in between Truckee and King's Beach (Figure 1). The Unit 7 plots are located in a residential area just off Big Springs Drive, northwest of the Village at Northstar. The Unit 7 monitoring site consists of three discrete slopes with two different treatments. The Overlook East and Hydroseed plots span the southwest corner of the intersection of Big Springs Drive and Overlook Place. Overlook West lies at the west end of Overlook Place, on the south side of the street near the cul-de-sac (Figure 2).

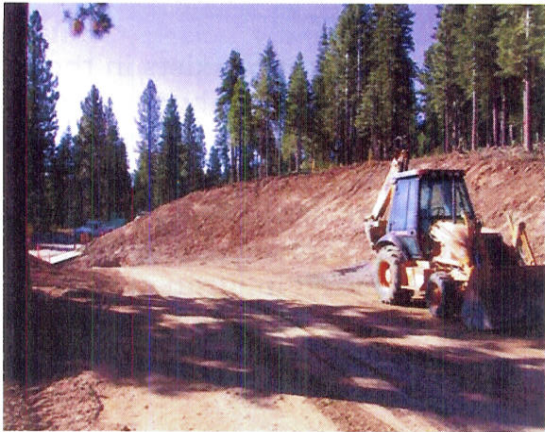
Figure 3. Unit 7, Overlook East and West, pre-treatment.

The treatments at Overlook East and West were completed in 2001. Figure 3 and Figure 4 show Overlook East and West before and after they were treated. Originally, both plots were treated with the same surface hydroseed treatment used in the Hydroseed plot.

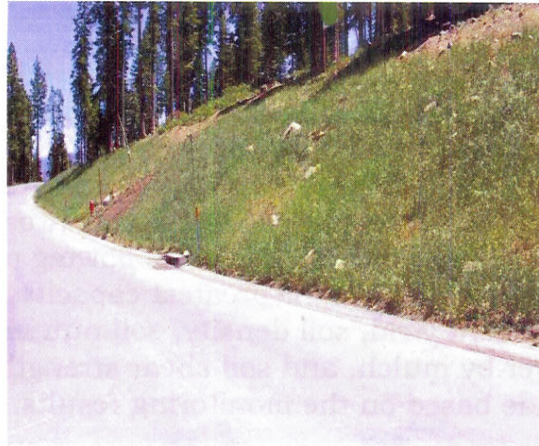
Figure 4. Unit 7 Overlook West, post-treatment.

In 2001, both plots were tilled to a depth of 8 to 12 inches (20 to 30 cm), first using a backhoe with teeth extensions, then with a reach forklift. Four inches (10.2 cm) of aged wood waste (woodchips) were tilled into the soil and then 1,500 lbs/acre (1,684 kg/ha) of Biosol was incorporated. A native seed mix was lightly raked into the soil at a rate of 110.5 lbs/acre (124 kg/ha) and a Shred-vac blower was used to spread 1.25 inches (3.2 cm) of pine needle mulch (Table 1). Tackifier was then applied.

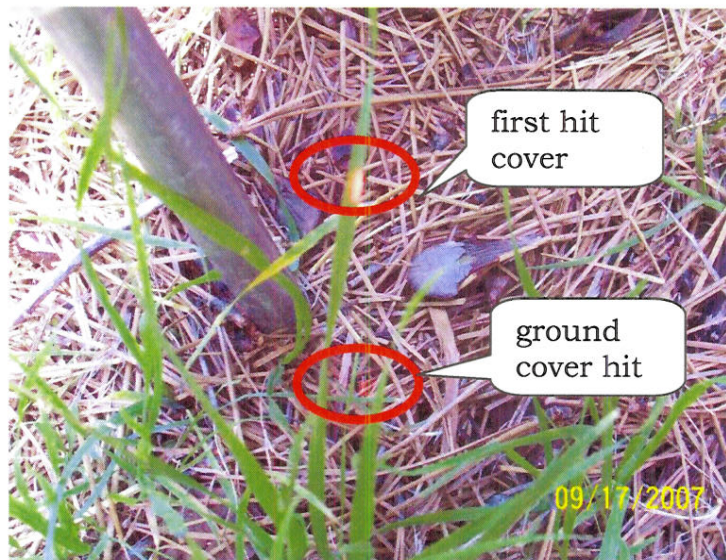
- 1) the first hit cover, which represents the first object intercepted starting from a height of 3.3 feet (1 m) above the ground
- 2) the ground cover hit

The first hit cover measures the foliar cover by plants (leaves and stems). It does not measure the part of the plant actually rooted in the ground. The first hit vegetation is then moved aside and a ground cover hit (second hit) measures the presence of litter/mulch, basal (or rooted) plant cover, rock and woody debris and/or bare ground.

Figure 7. Cover pointer rod with first hit cover and ground cover hit by the laser pointer. The laser pointer hits are circled in red. The first hit cover is a native grass and the ground cover hit is pine needle mulch.

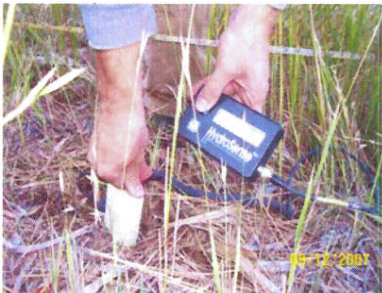
A hydrometer was used to measure volumetric soil moisture content adjacent to the penetrometer readings at a depth of 4.7 inches (12 cm) (Figure 10).

Figure 10. Conducting soil moisture readings along transects.

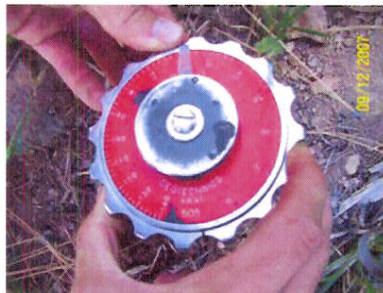
In 2007, soil strength was tested along cover point transects in the same manner as soil density and soil moisture. A hand-held shear vane with 1.5 inch (3.8 cm) long blades was pushed into the soil to a depth of 3 inches (7.6 cm) and turned until the soil could no longer resist the force exerted by the blades and the soil structure fractured or deformed (Figure 11). This force was then recorded as the “shear stress” in kilopascals (kPa). Forty kilopascals was the maximum force the shear vane could measure. Shear stress values greater than 40 kPa were recorded as 40 kPa.

Figure 11. Soil shear strength tester in use.

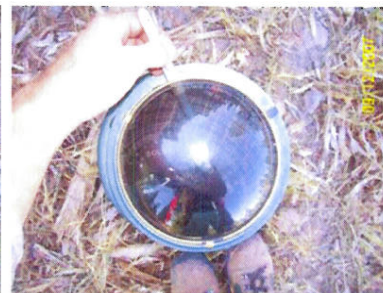
Solar radiation measurements were taken at each plot using a Solar Pathfinder (Figure 12). Solar input affects evaporation rates and soil temperature, which may affect time of seed germination, germination rate, rate of plant growth and soil microbial activity. It is an important variable to consider when monitoring plant growth and soil development.

Figure 12. Solar pathfinder in use.

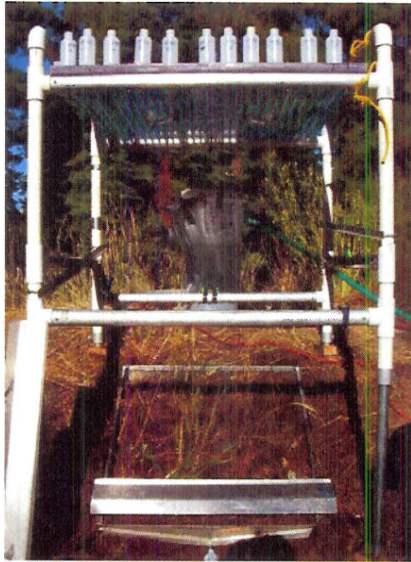
In 2006 and 2007, rainfall simulation was conducted at each plot (Figure 5). The rainfall simulator “rains” on a square plot from a height of 3.3 feet (1 m) (Figure 14 and Figure 15). The rate of rainfall is controlled, and runoff is collected from a trough at the bottom of a 6.5 square feet (0.6 m²) frame that is pounded into the ground. The volume of water collect is measured; then the volume of infiltration is calculated by subtracting the volume of runoff from the total volume of water applied to the plot. If runoff was not observed during the first 30 minutes, the simulation was stopped. The average steady state infiltration rate was calculated and will hereafter be referred to as “infiltration rate”. The collected runoff samples were then analyzed for the average steady state sediment yield (hereafter referred to as “sediment yield”).

Figure 14. Rainfall simulator and frame

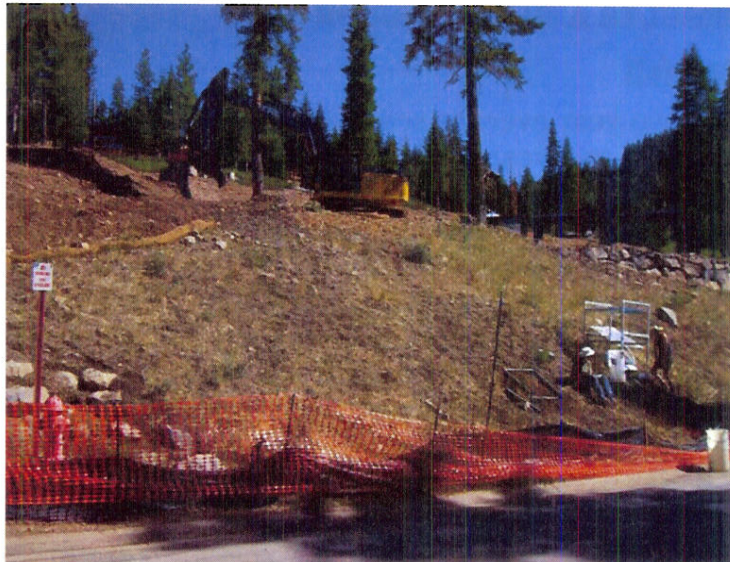
Figure 15. The rainfall simulator and frames at the Overlook West plot.

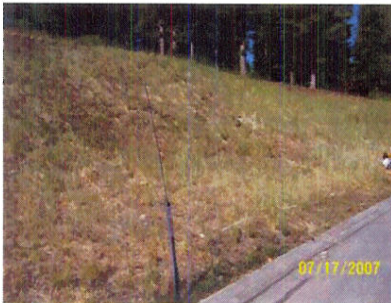
Figure 23. Overlook East, 2007. High plant cover is evident.

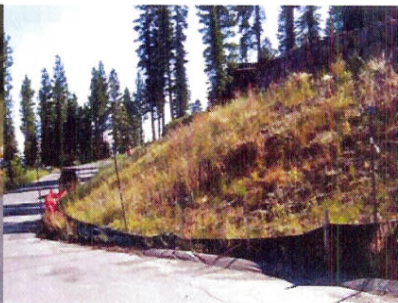
Figure 24. Overlook West, 2006. High plant cover is evident.
